Document Version Control		
Document Number	Version Number	Release Date
TSB0001	0	14/12/2016

TALON SERVICE BULLETIN: WEAR INDICATION AND PROFILE

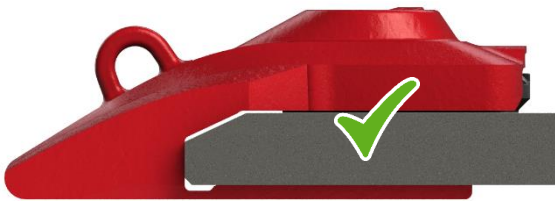
The large surface area on the base of the Talon shrouds also helps to increase the life of the shrouds in service. The wear profile of the shrouds should be monitored to ensure maximum life can be achieved from the system.

Wear profile should be parallel to lip plate.

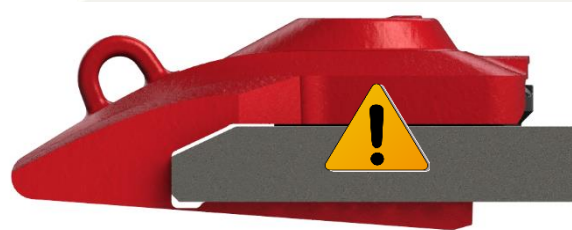
If profile is angled to the lip plate. Check application and or installation.
